FLOOD PLAIN INFORMATION

**WALLA WALLA RIVER
VICINITY OF MOJONNIER
WALLA WALLA COUNTY,
WASHINGTON**

**PREPARED FOR WALLA WALLA COUNTY BY THE DEPARTMENT OF THE ARMY
WALLA WALLA DISTRICT, CORPS OF ENGINEERS, WALLA WALLA, WASHINGTON**

FEBRUARY 1976

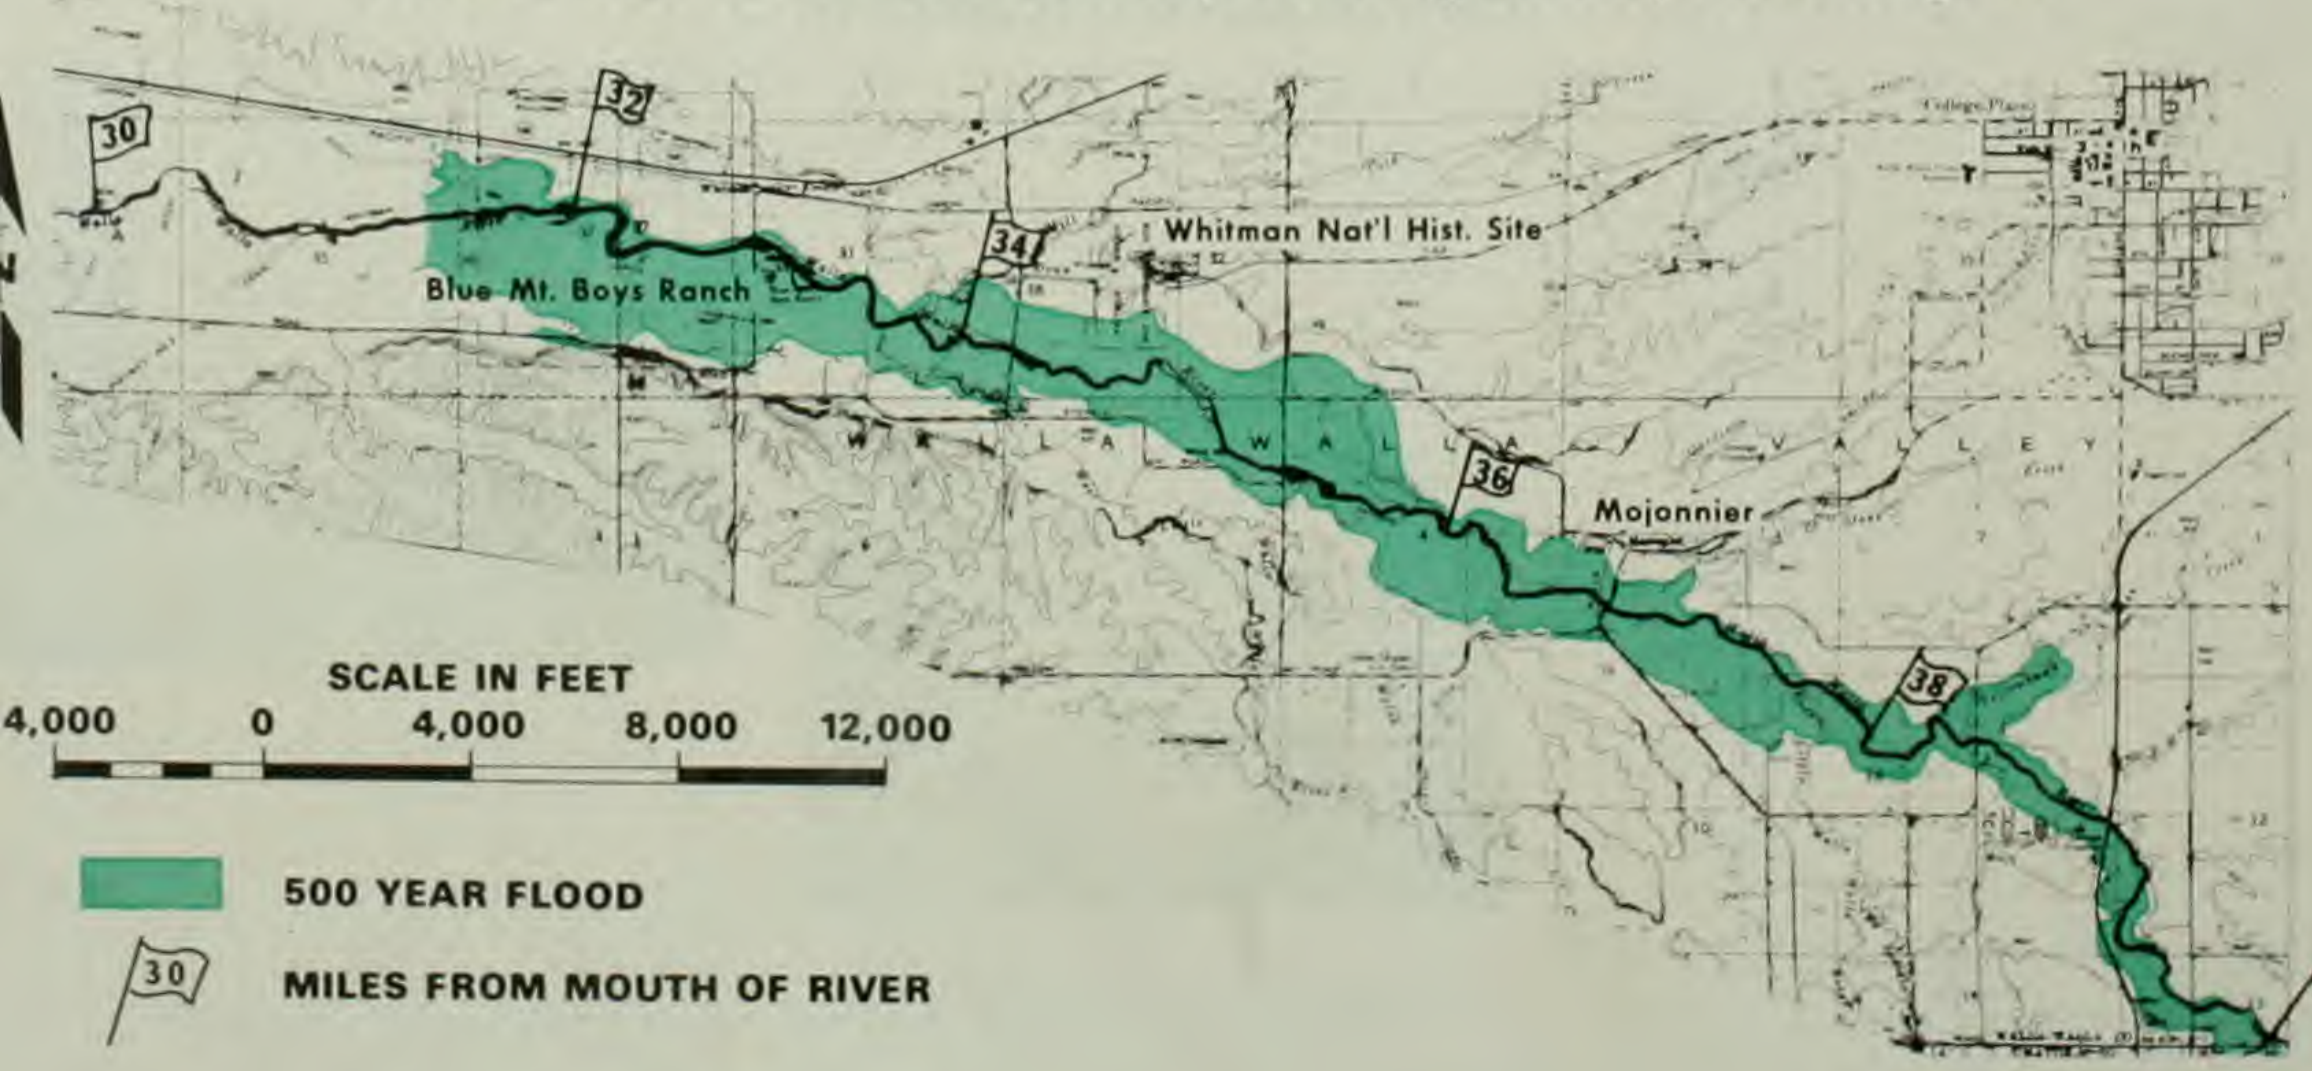
FLOOD PATTERN for vicinity of Mojonnier, Washington

Flood Magnitude
Flow-cfs*
Below confluence of Mill Creek
Large (100 year flood) 18,000
Very Large (500 year flood) 35,000
* Cubic feet per second

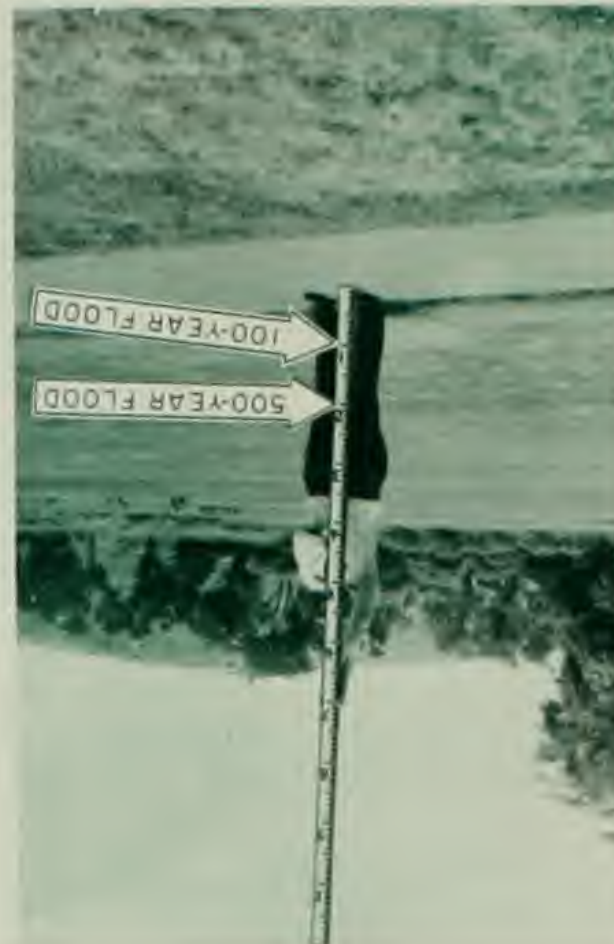
POTENTIAL FLOOD HEIGHTS AT THE WHITMAN NATIONAL HISTORICAL SITE

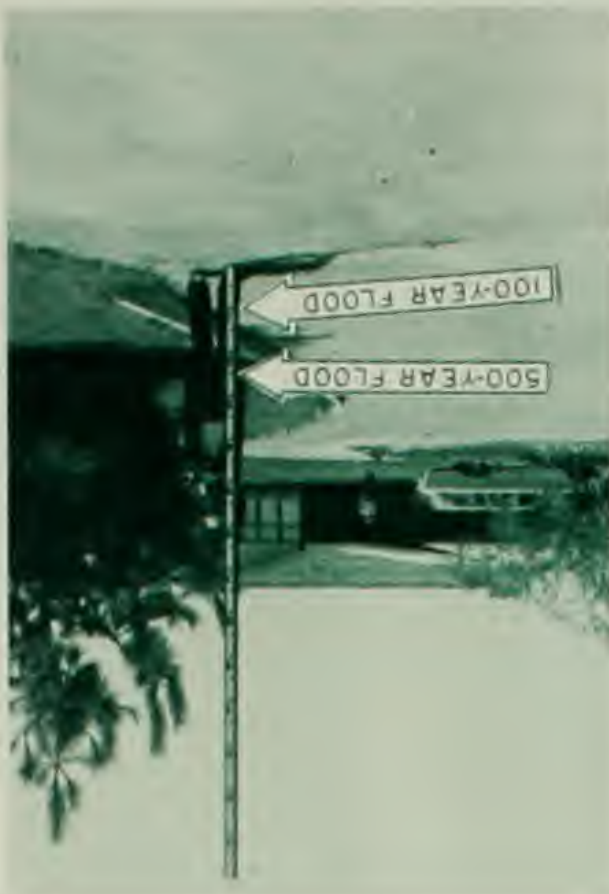
POTENTIAL FLOOD HEIGHTS AT THE BLUE MOUNTAIN BOY'S RANCH

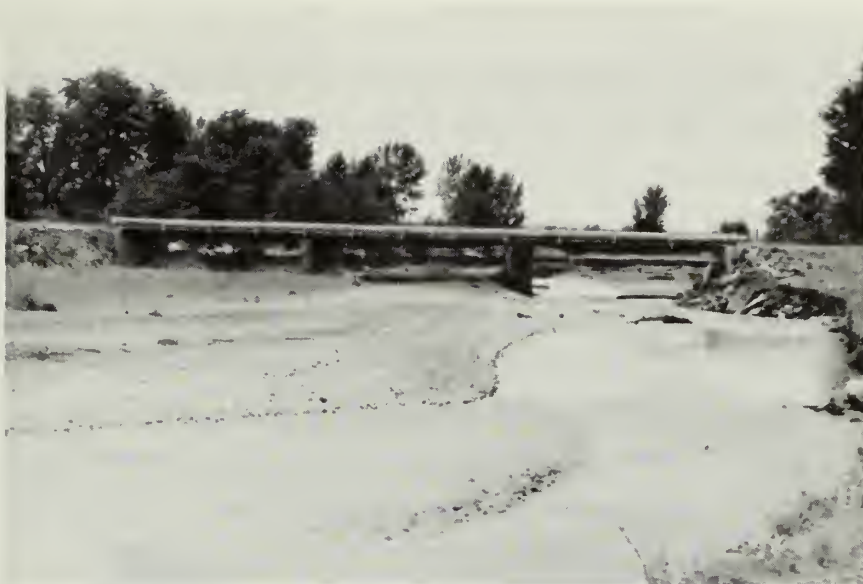
Downstream view of Last Chance Road Bridge at Cross Section 22.

Obstructions to floodflows: Natural obstructions to floodflows include trees, brush, and other vegetation growing along the streambanks and in floodway areas. Man-made encroachments on or over the streams, such as dams and bridges can also create more extensive flooding than would otherwise occur. Representative obstructions to floodflows are shown in Figures 1 and 2.

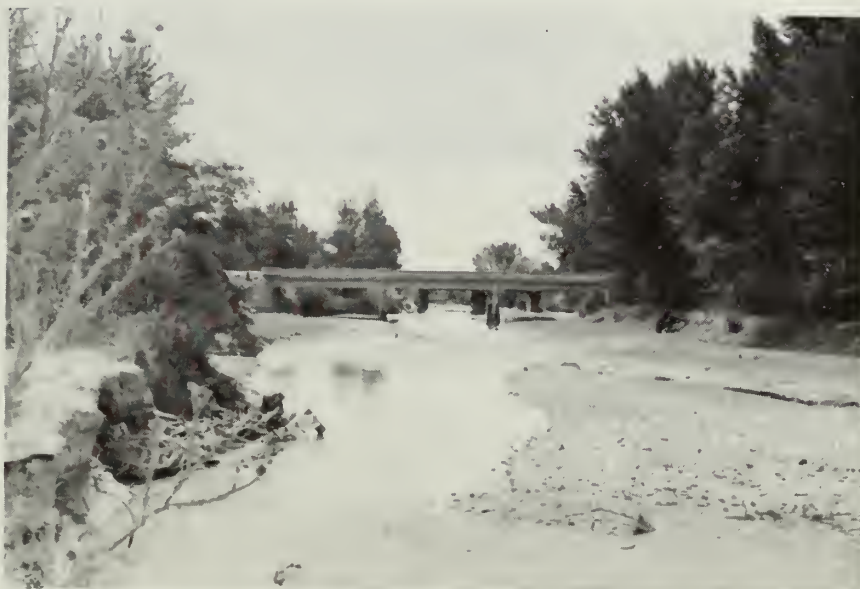
Downstream view of bridge to Mojonnier at Cross Section 32.

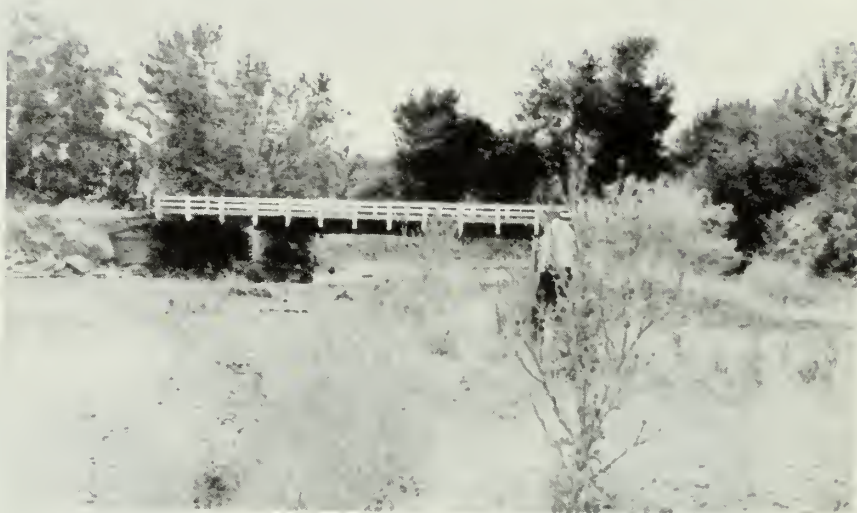
Downstream view Pepper Crossing Bridge at Cross Section 55.

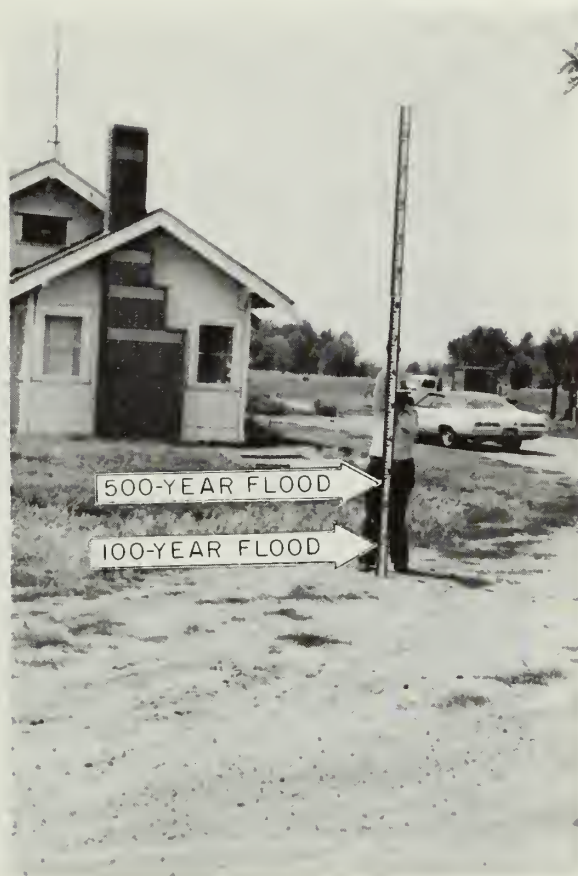
Flood heights at home 250 feet south of
bridge to Whitman National Historical Site.

Photographs, Future Flood Heights: The levels that the 100-Year and 500-Year Floods are expected to reach at various locations in the study area are indicated in the following photographs:

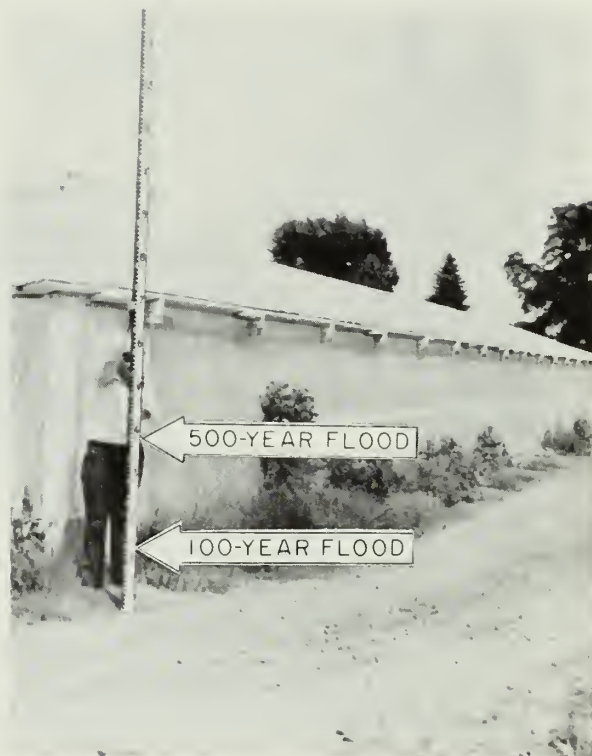
Flood heights at Hamada Brothers
Greenhouse.

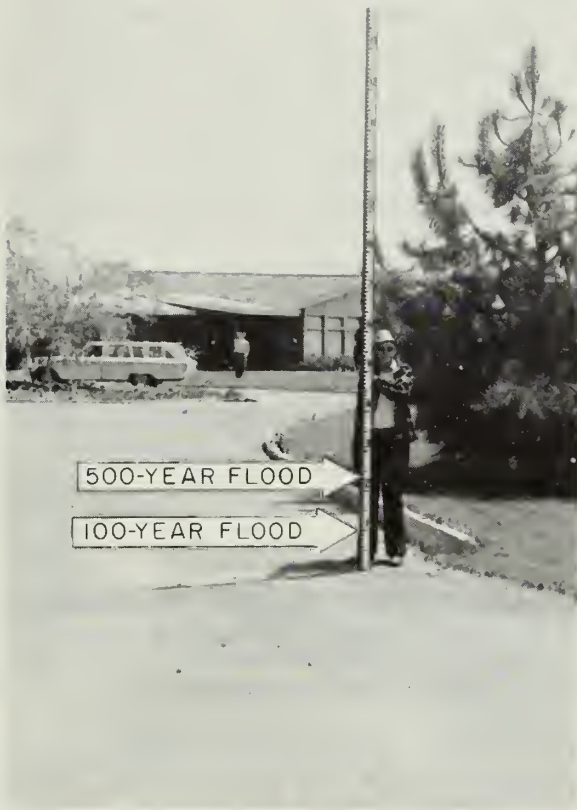
Flood heights in front of Blue Mountain Boys' Ranch.

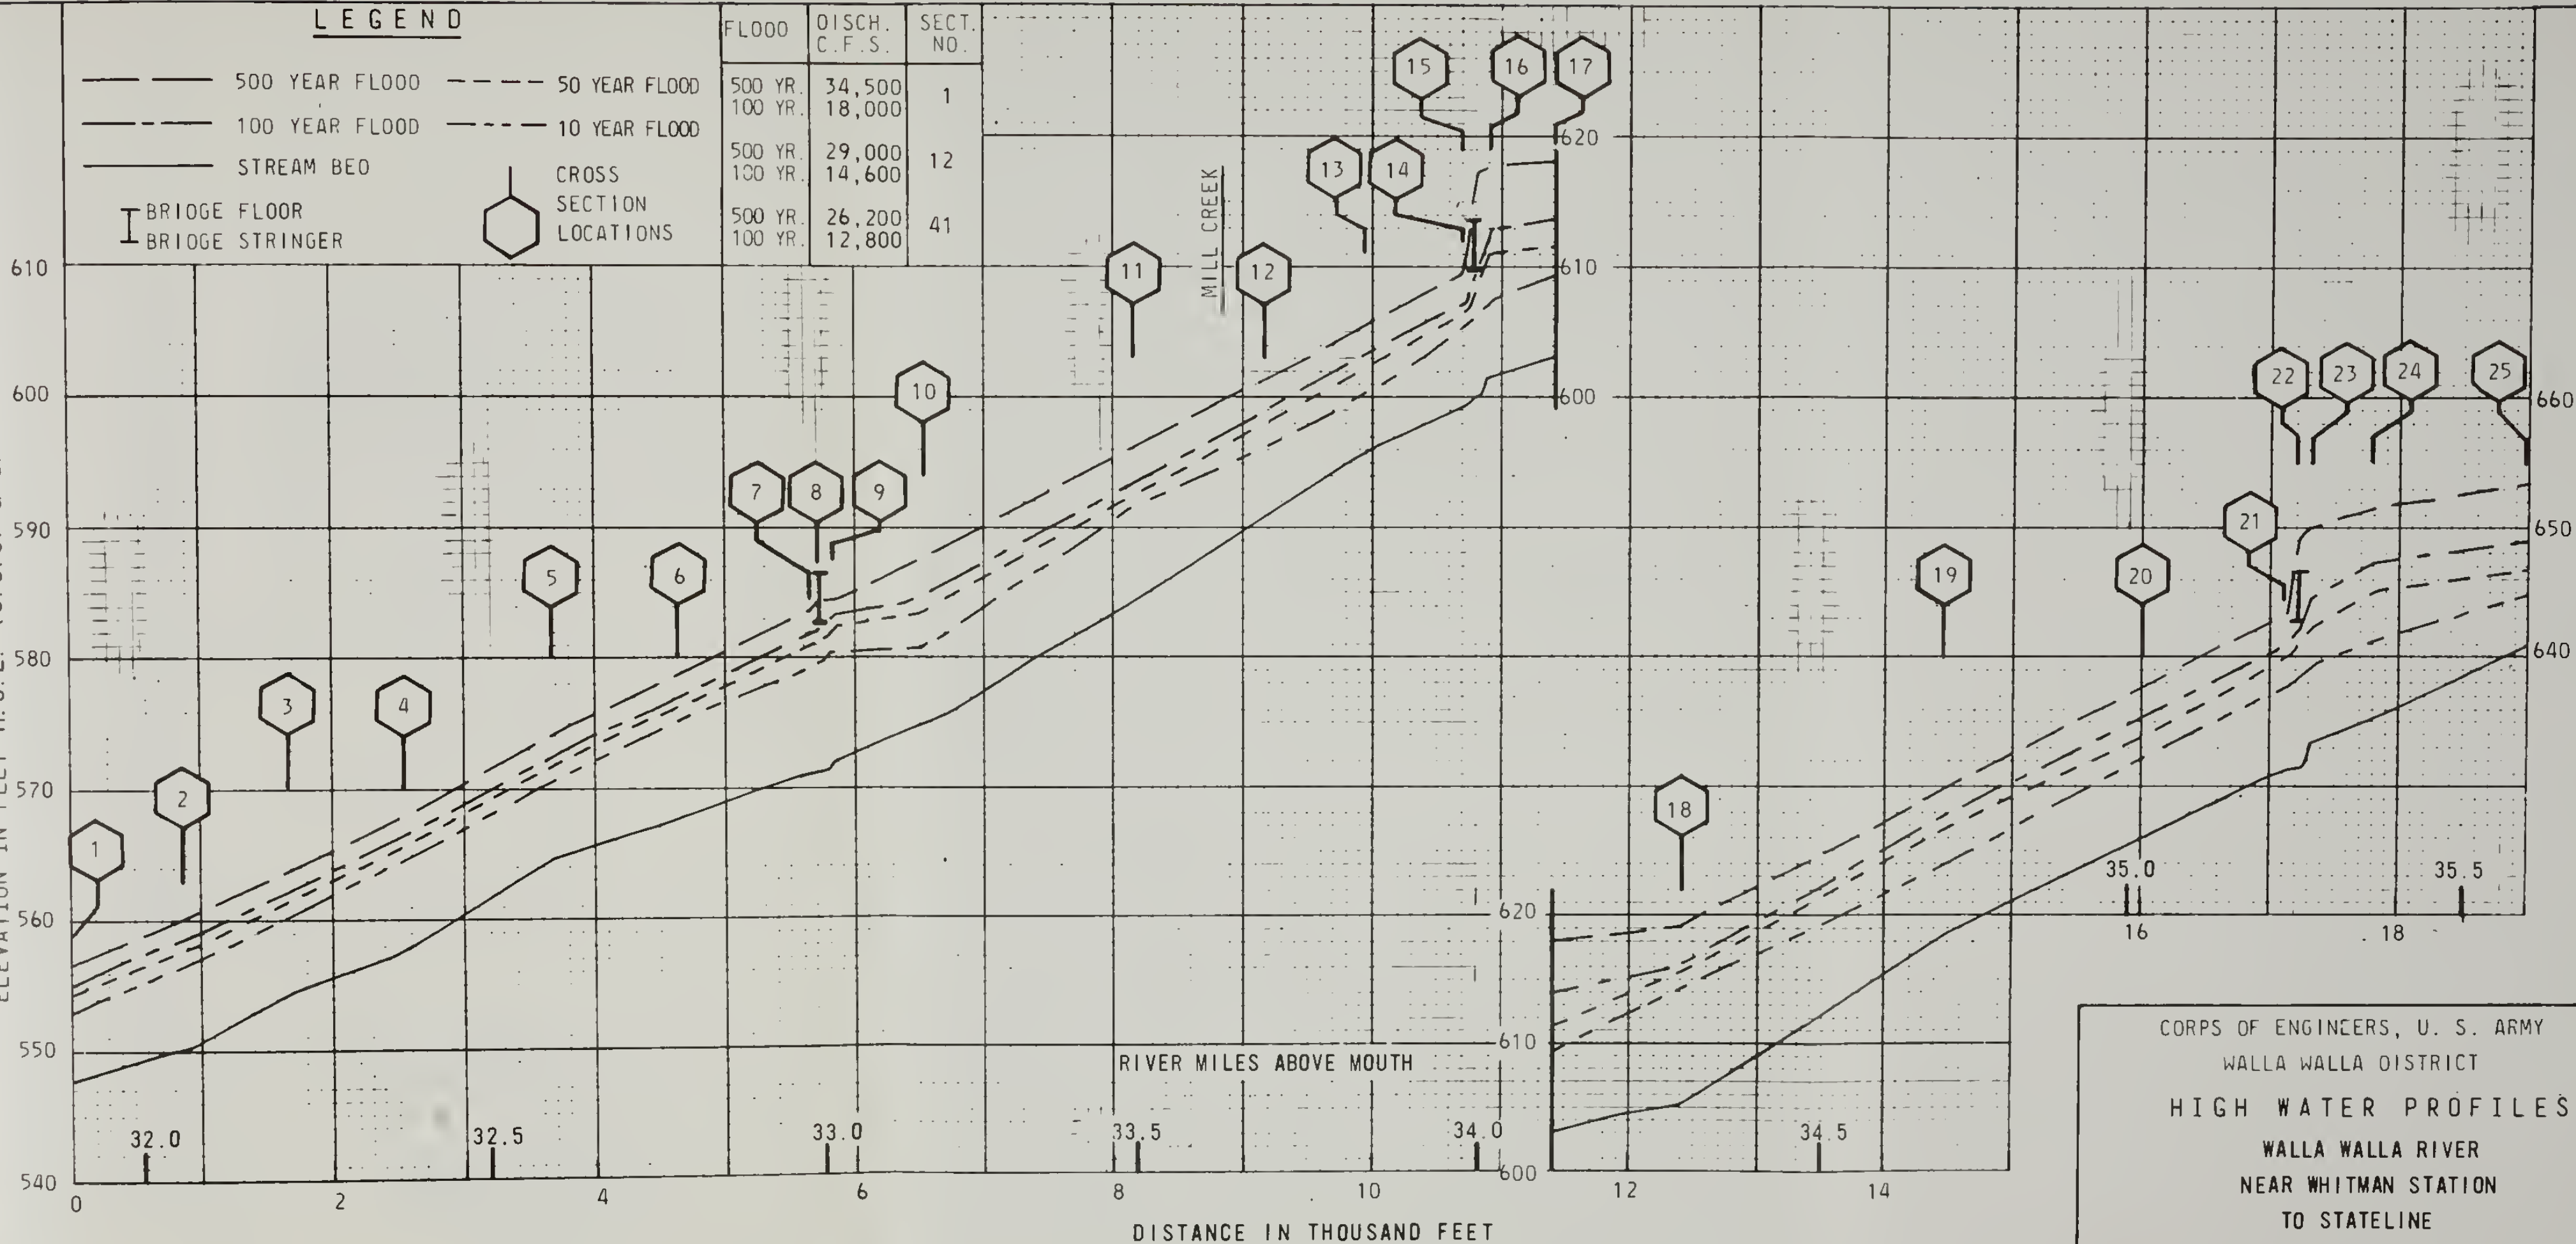
FLOOD	DISCH. C.F.S.	SECT. NO.
500 YR. 100 YR.	34,500 18,000	1
500 YR. 100 YR.	29,000 14,600	12
500 YR. 100 YR.	26,200 12,800	41

CORPS OF ENGINEERS, U. S. ARMY
WALLA WALLA DISTRICT
HIGH WATER PROFILES
WALLA WALLA RIVER
NEAR WHITMAN STATION
TO STATELINE
JUNE 1975

The 100-Year Flood is defined as one that could occur once in 100 years on the average, although it could occur in any year. The peak flow of this flood was developed from statistical analyses of streamflow and runoff characteristics for the stream under study. However, limitations in these records required analyses on a regional rather than a watershed basis. In determining the 100-Year Flood for the Walla Walla River study area, statistical studies were made using up to 44 year's record of flood data from U.S. Geological Survey gaging stations throughout the Walla Walla River drainage. Peak flows thus developed for the 100-Year Flood at selected locations in the study area are shown in TABLE 3. The relative water surface elevations for the 100-Year flood are shown on Plates 6 through 8.

The 500-Year Flood is defined as one that could occur once in 500 years on the average, although it could occur in any year. The peak flow of this flood was developed from statistical analyses of streamflow and runoff characteristics for the stream under study. However, limitations in these records required analyses on a regional rather than a watershed basis. In determining the 500-Year Flood for the Walla Walla River, statistical studies were made using up to 44 year's record of flood data from the U.S. Geological Survey gaging stations throughout the Walla Walla River drainage. Peak flows thus developed for the 500-Year Flood at selected locations in the study area are shown in TABLE 3. The relative water surface elevations for the 100-Year Flood and the 500-Year Flood are shown on Plates 6 through 8.

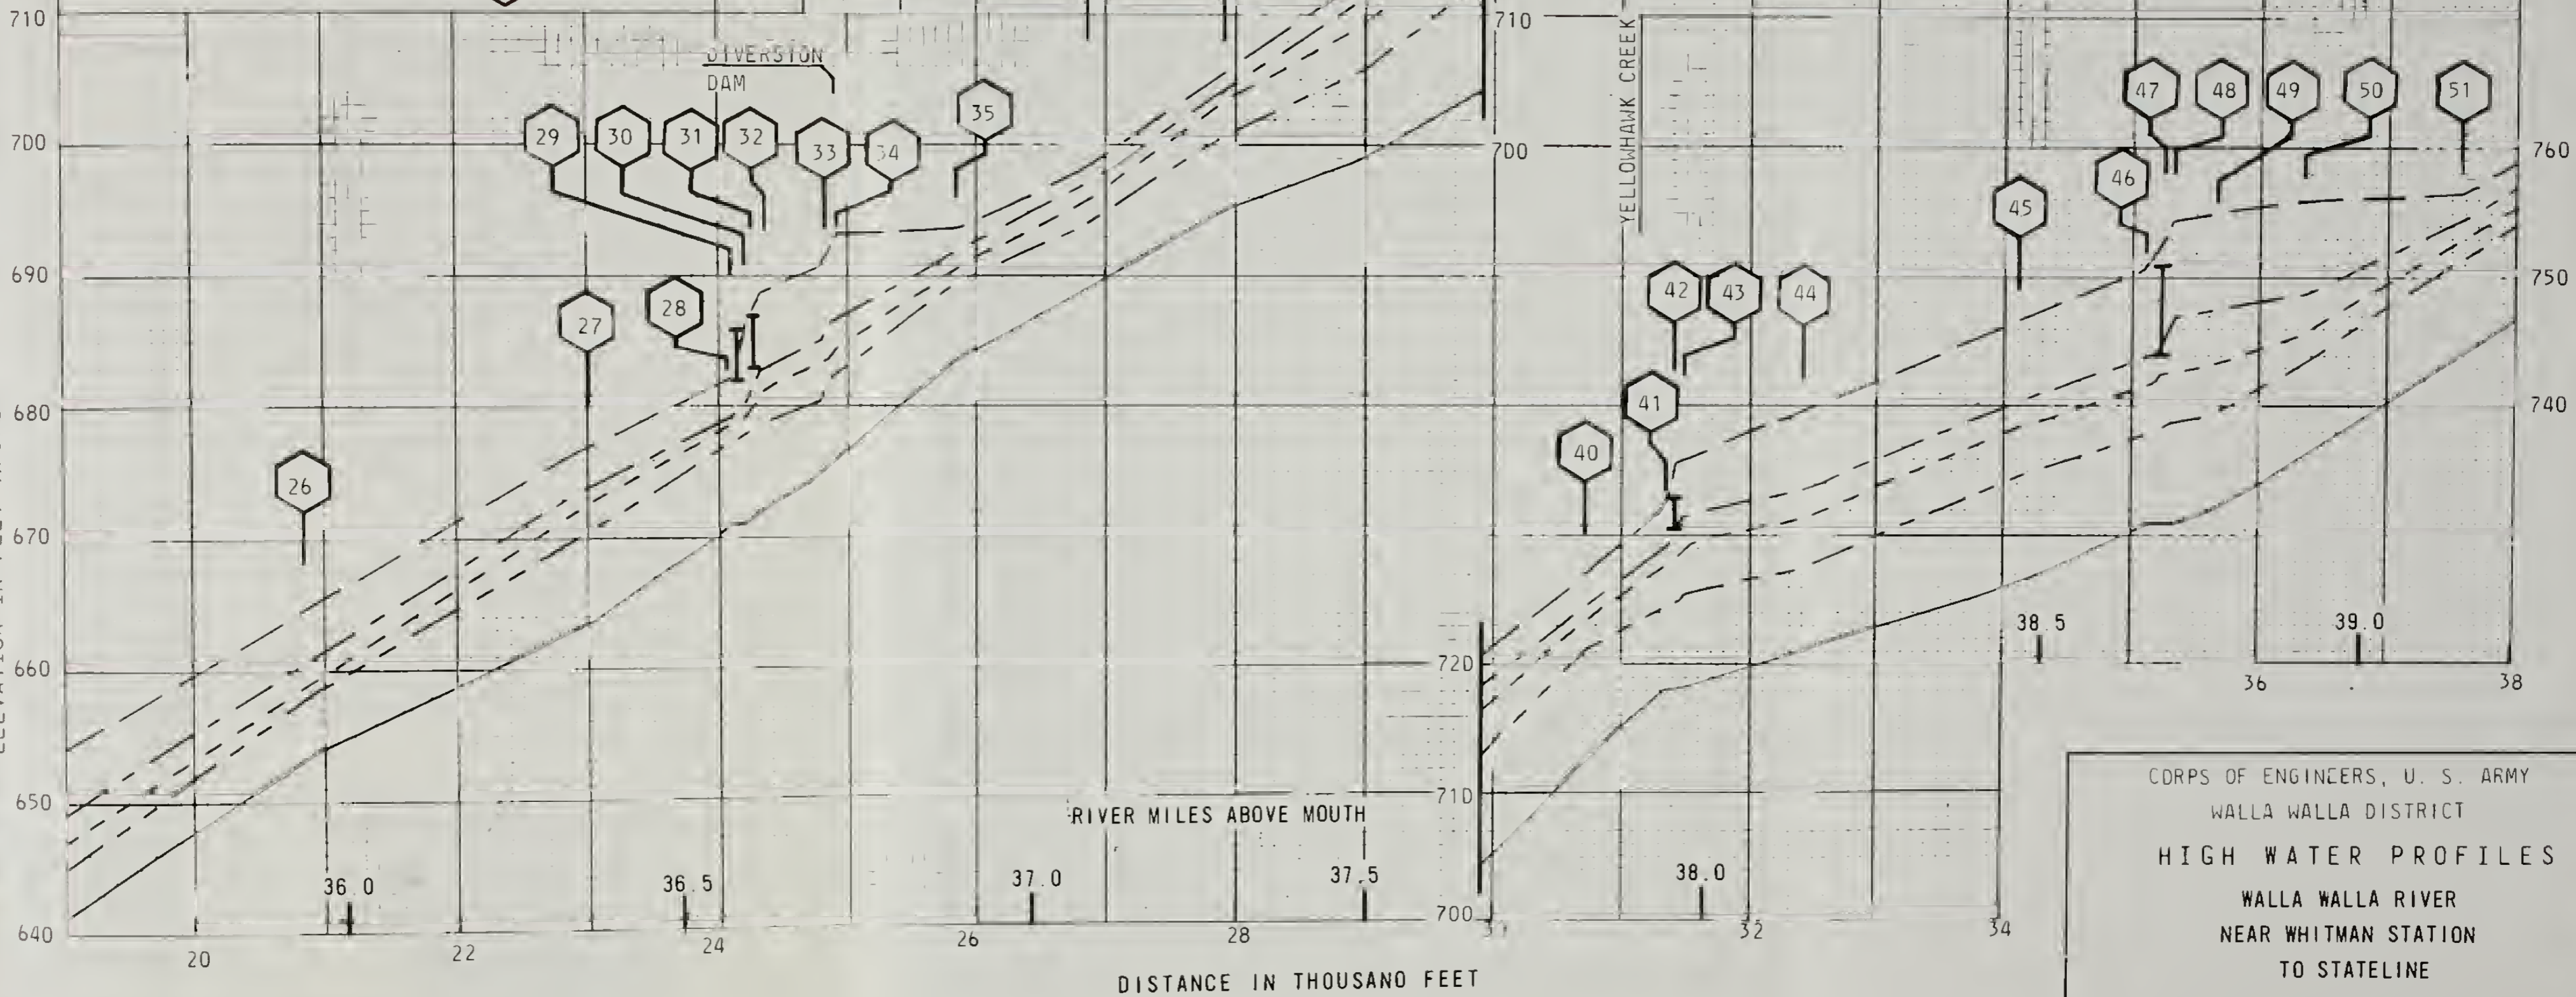
FLOOD	DISCH. C.F.S.	SECT. NO.
500 YR.	34,500	1
100 YR.	18,000	
500 YR.	29,000	12
100 YR.	14,600	
500 YR.	26,200	41
100 YR.	12,800

CORPS OF ENGINEERS, U. S. ARMY
WALLA WALLA DISTRICT
HIGH WATER PROFILES
WALLA WALLA RIVER
NEAR WHITMAN STATION
TO STATELINE
JUNE 1975

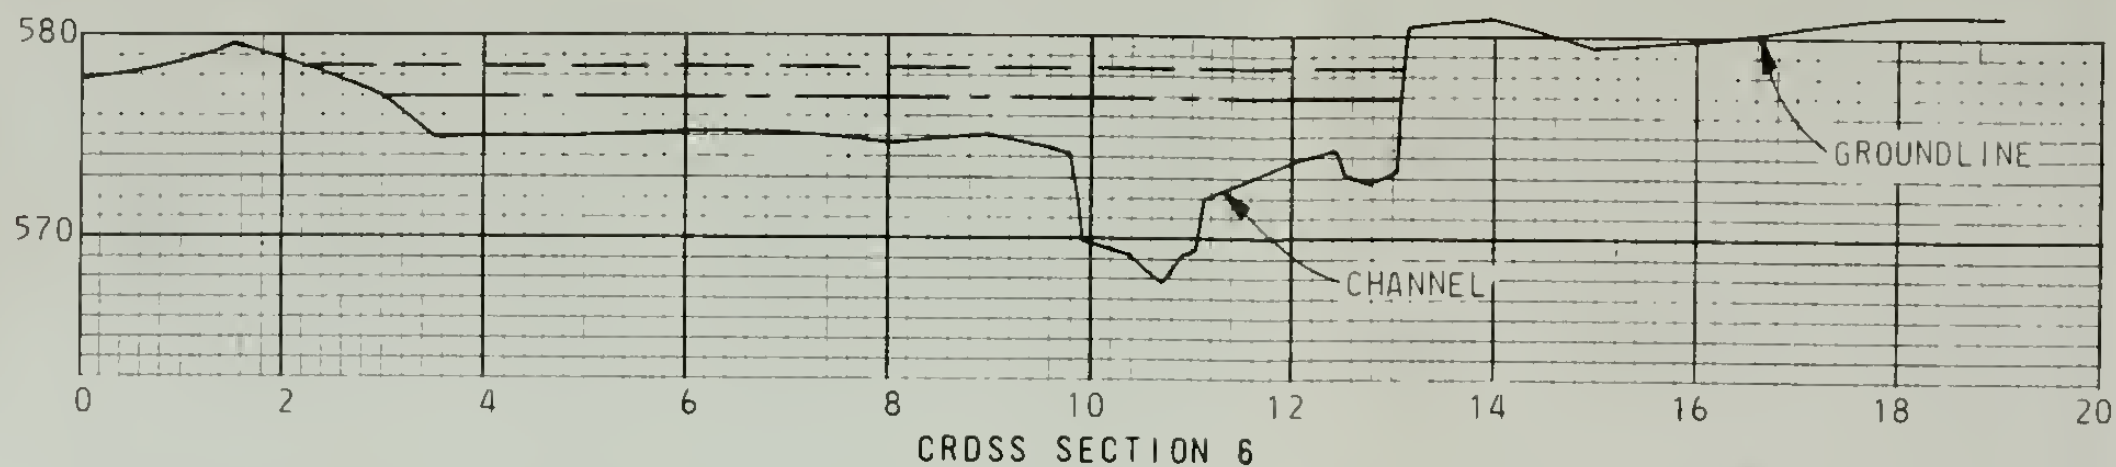
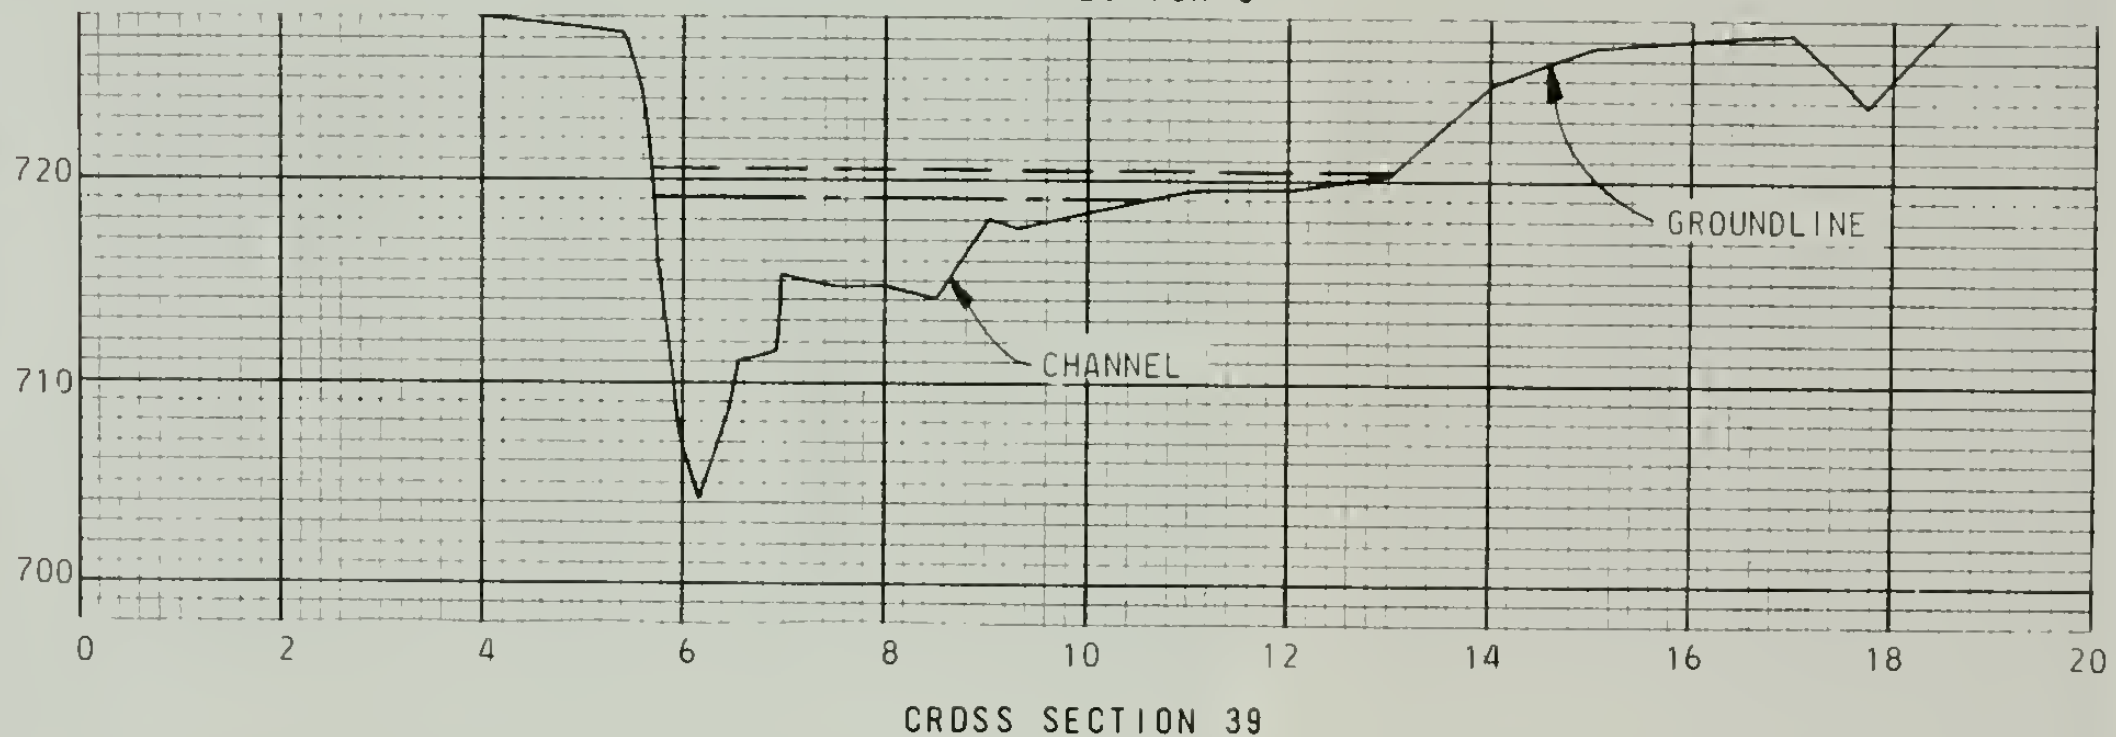
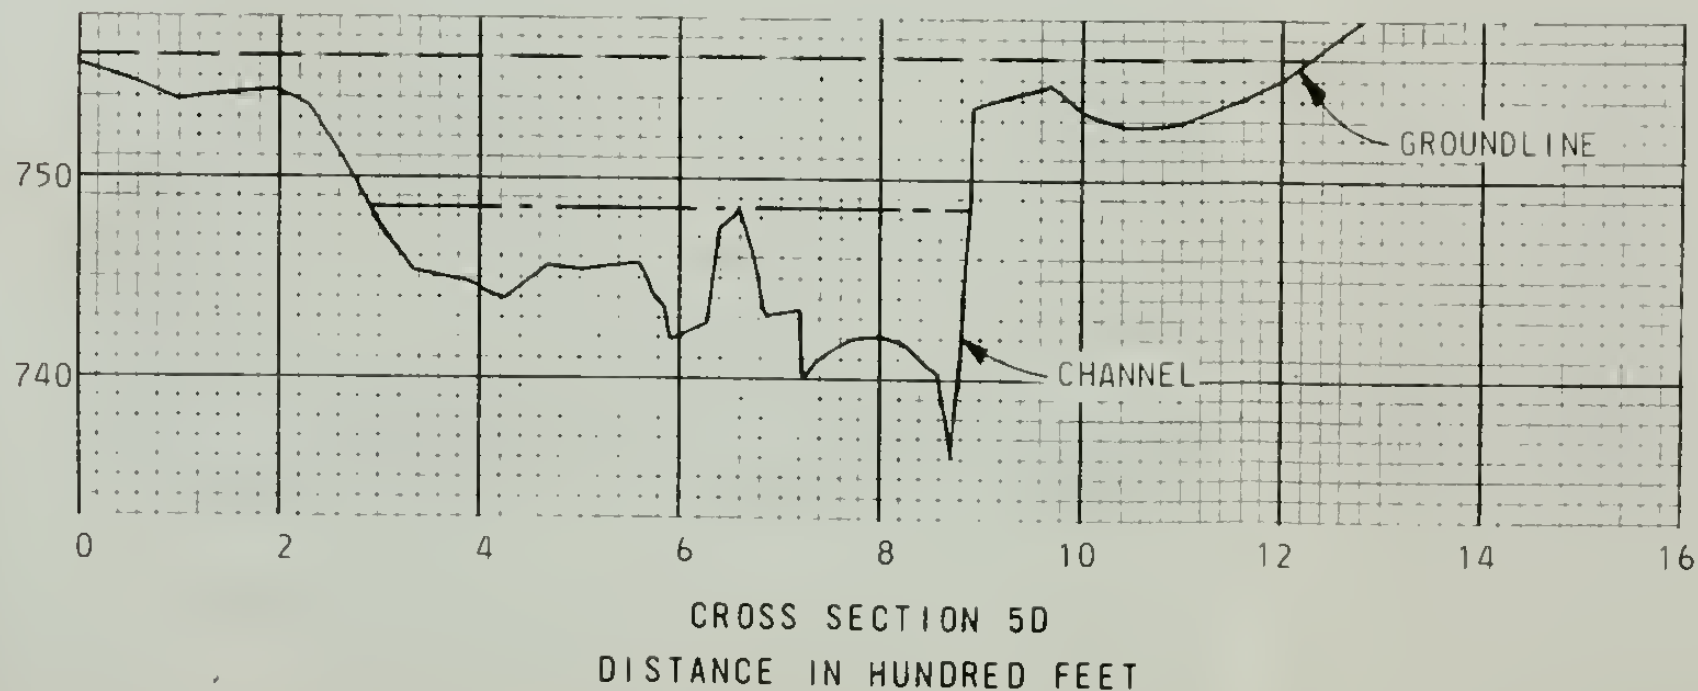
CORPS OF ENGINEERS, U. S. ARMY
WALLA WALLA DISTRICT
HIGH WATER PROFILES
WALLA WALLA RIVER
NEAR WHITMAN STATION
TO STATELINE
JUNE 1975

- 500 YEAR FLOOD
- 100 YEAR FLOOD
